# Hinkson Creek

Virtual Tour

# Hinkson Creek Facts

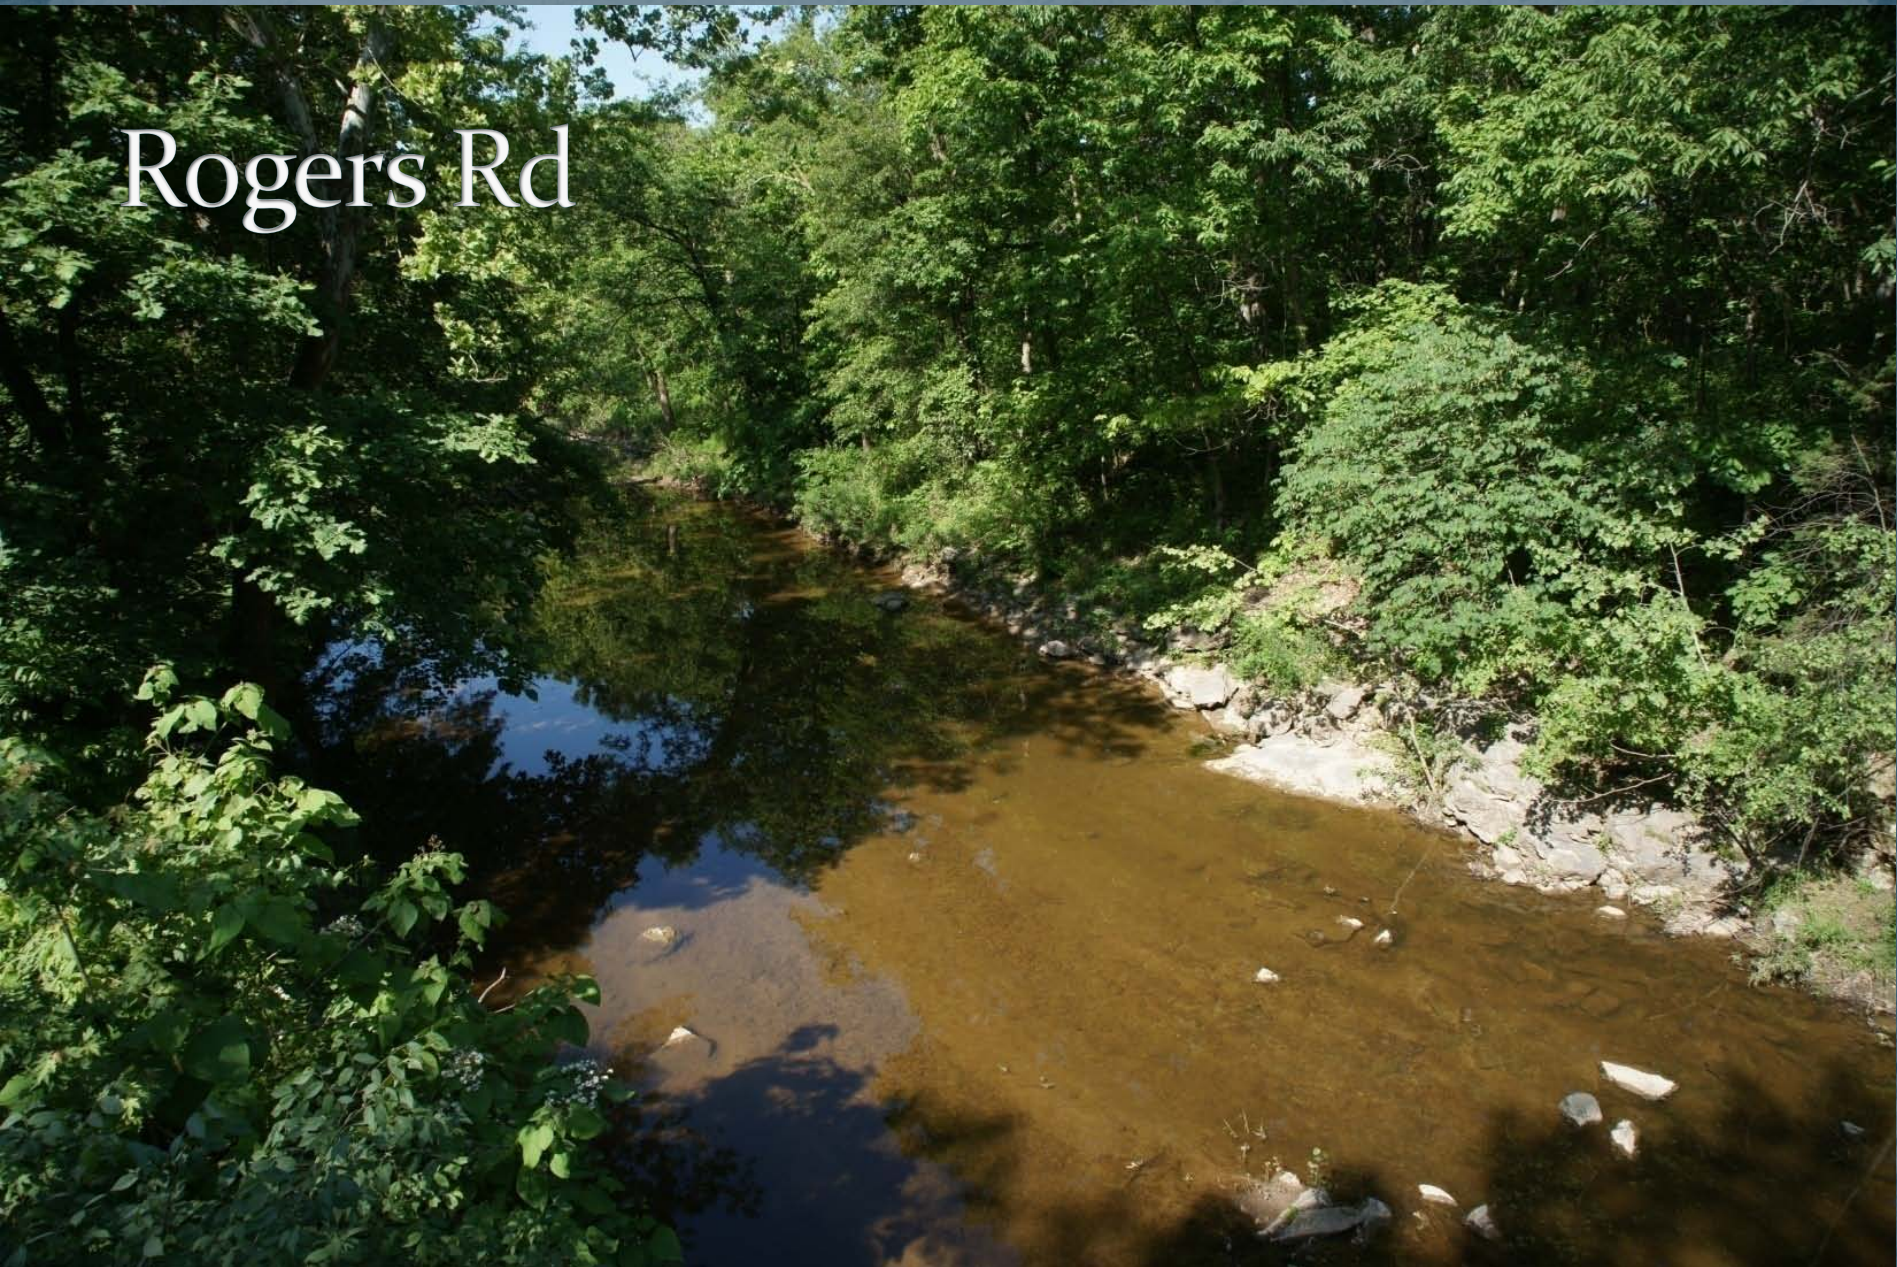
# Rogers Rd

- Debris above the bridge
- Bedrock control
- Bed material = silt clay

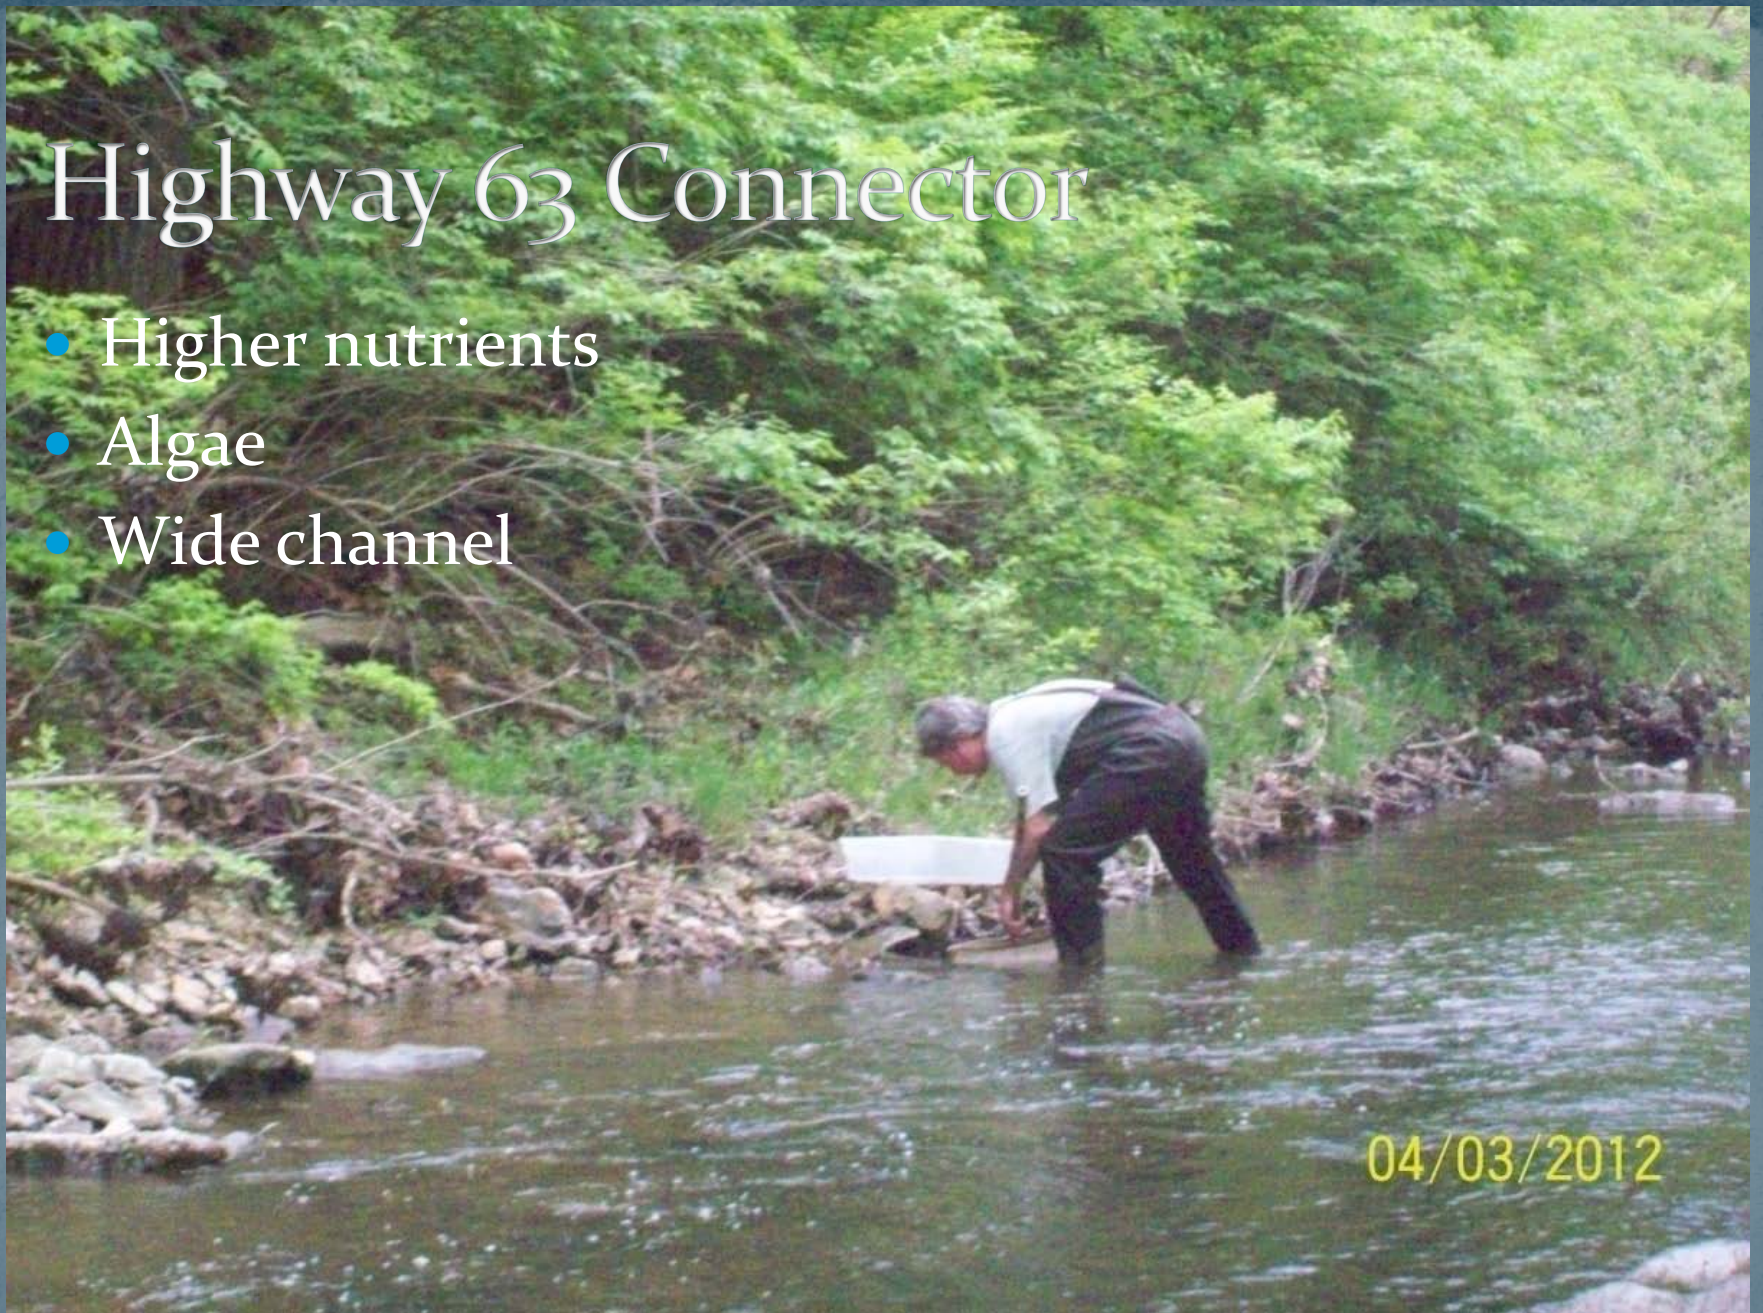
# Highway 63 Connector

- Higher nutrients
- Algae
- Wide channel

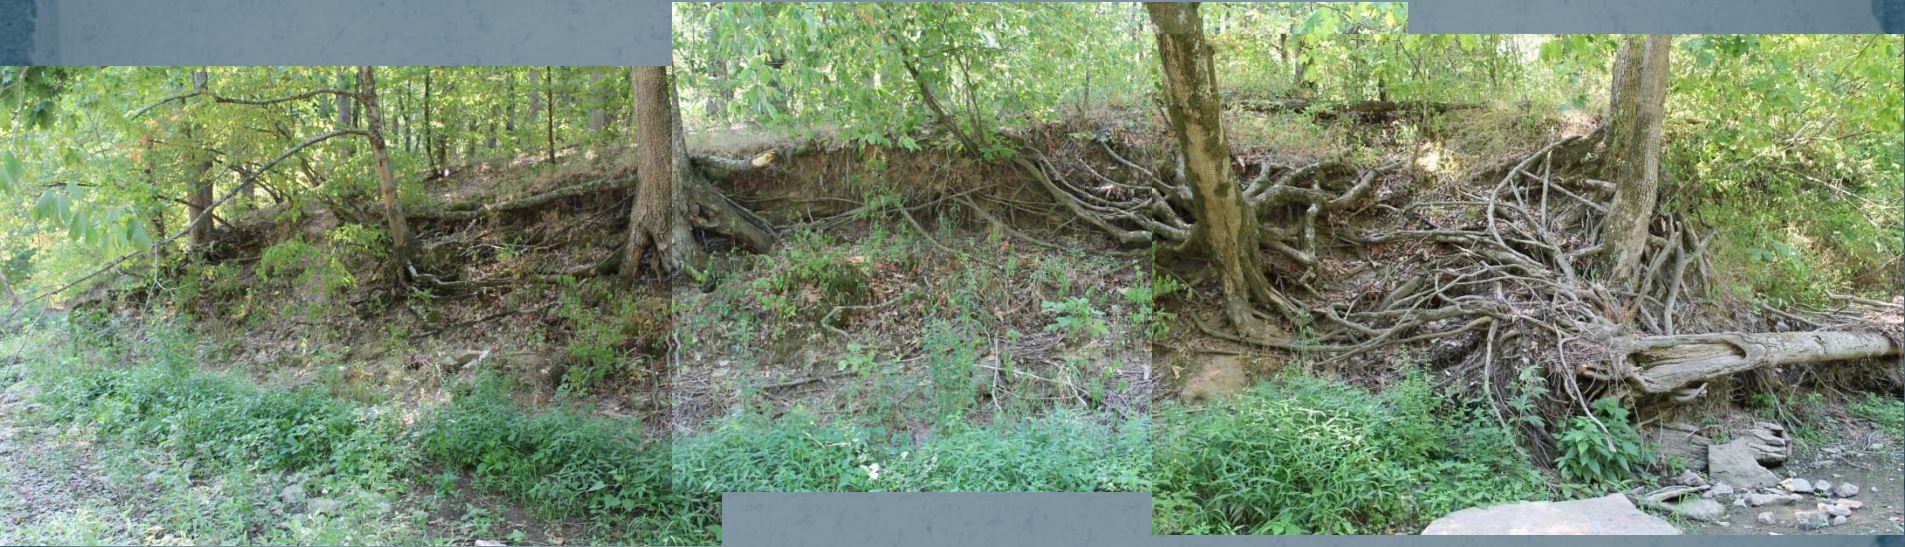
# Highway 63 connector

Urban Stream Syndrome - higher volume and peak flow leads to stream bank incision and stream bank collapse. Stream is disconnected from the floodplain - continuing a positive reinforcement loop

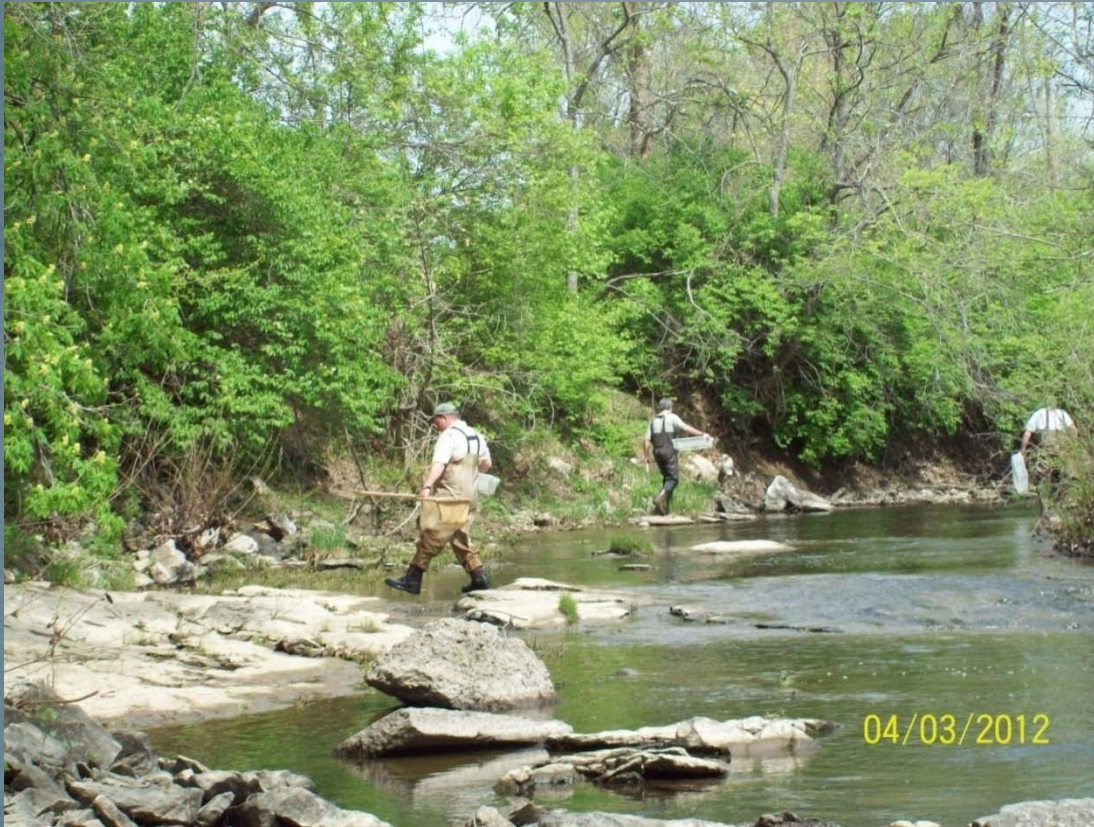
# Walnut, north of bridge

- Bedrock and boulders
- High algae, slippery
- Poor Riparian Corridor
- Black fly dominated
- Kids playing in creek

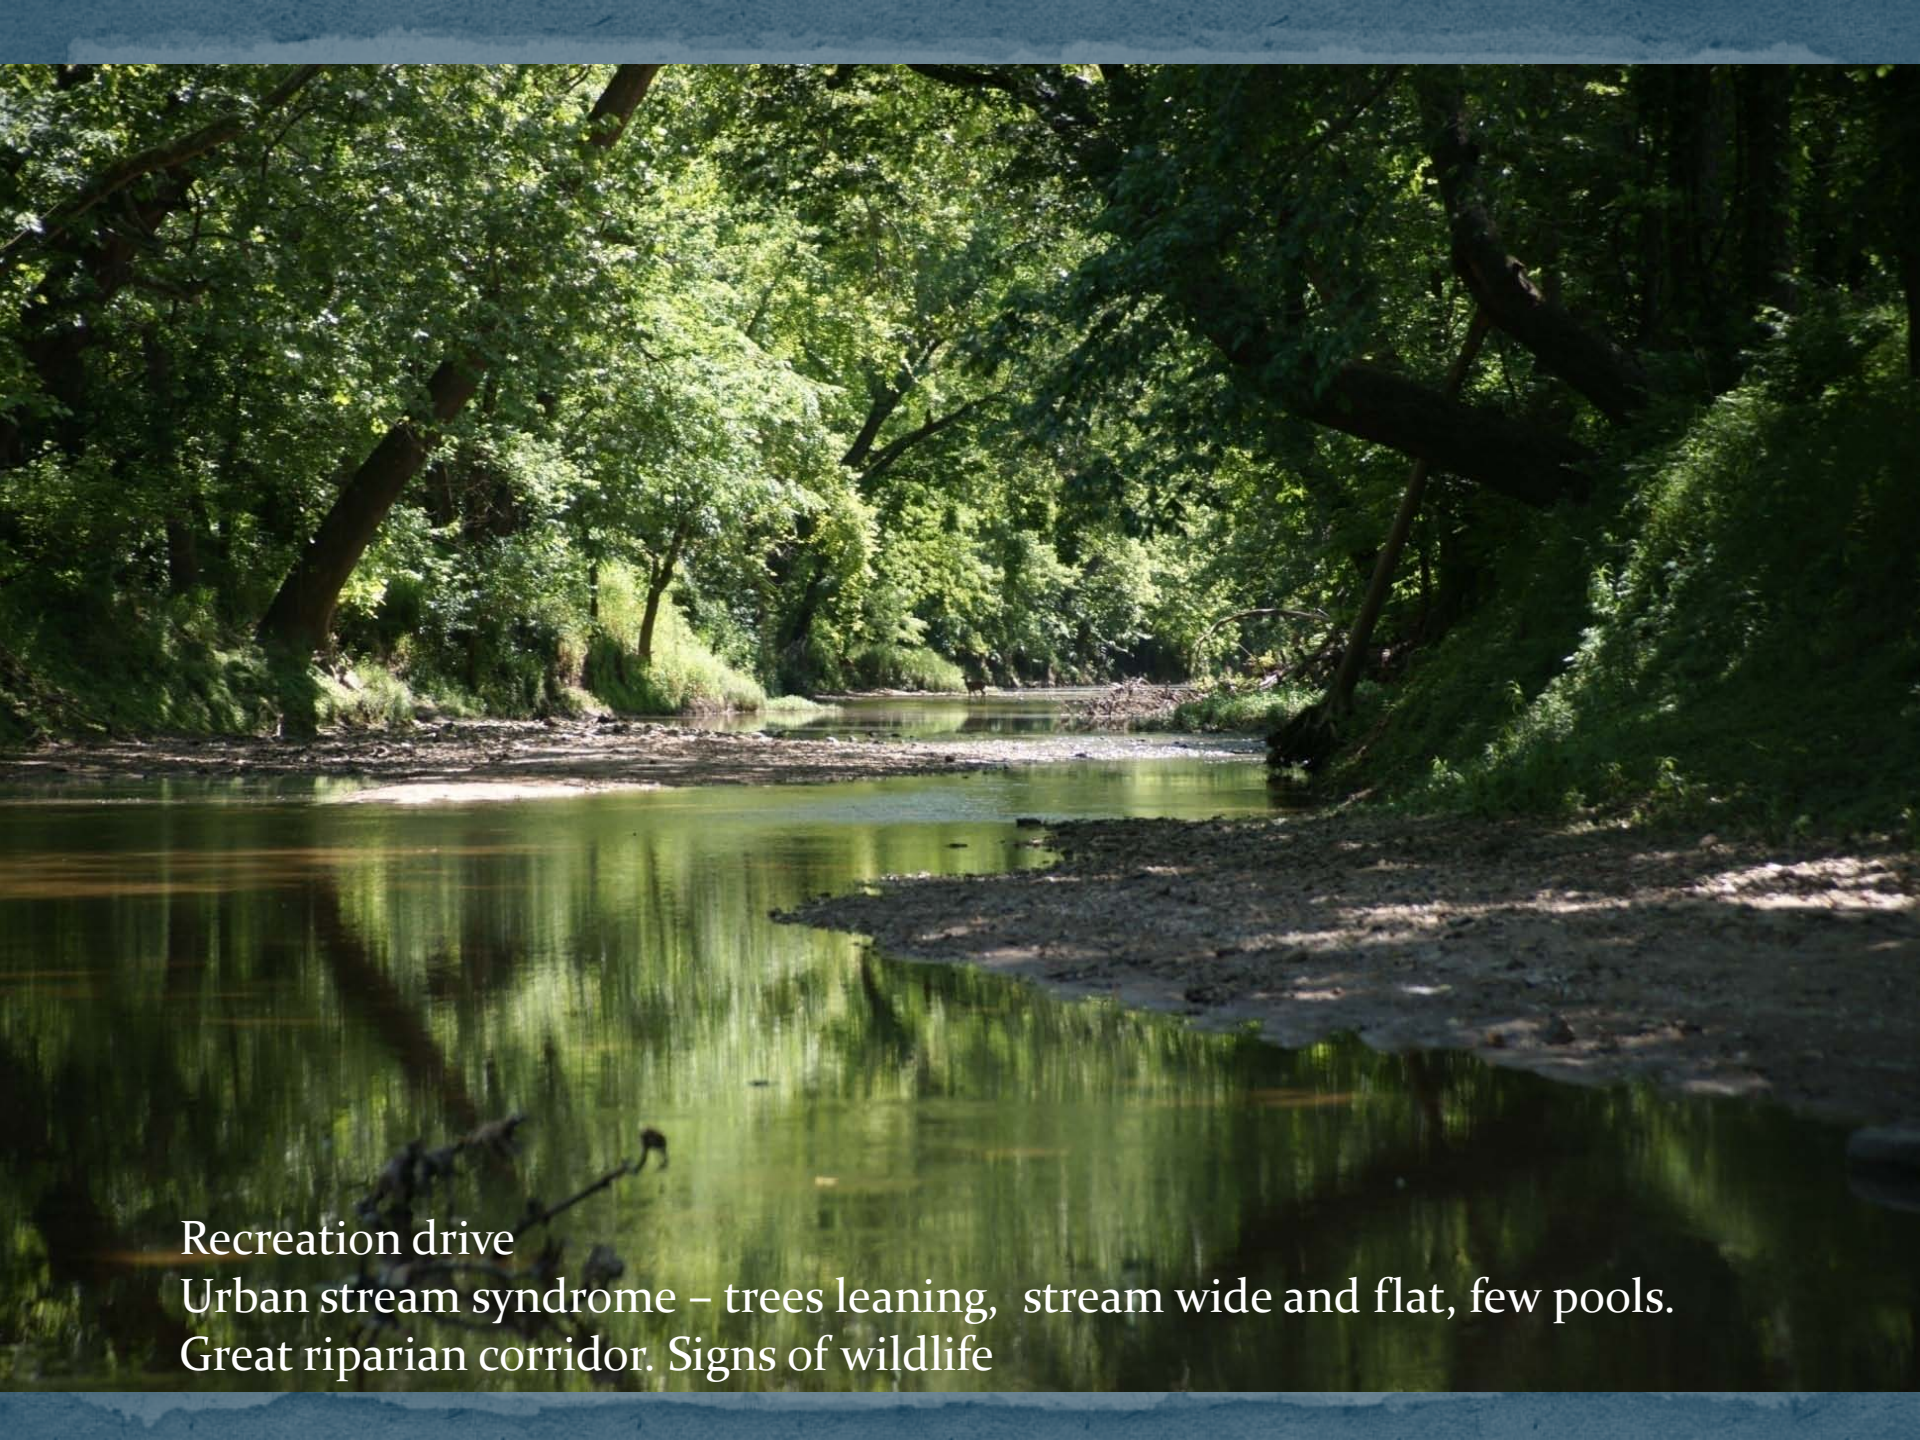
Recreation drive

Urban stream syndrome – trees leaning, stream wide and flat, few pools.

Great riparian corridor. Signs of wildlife

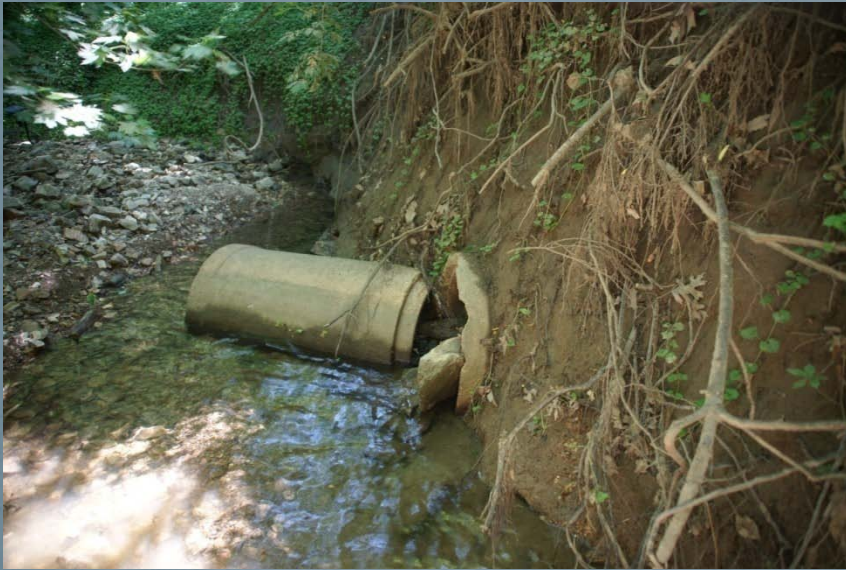
## Cracked pipe

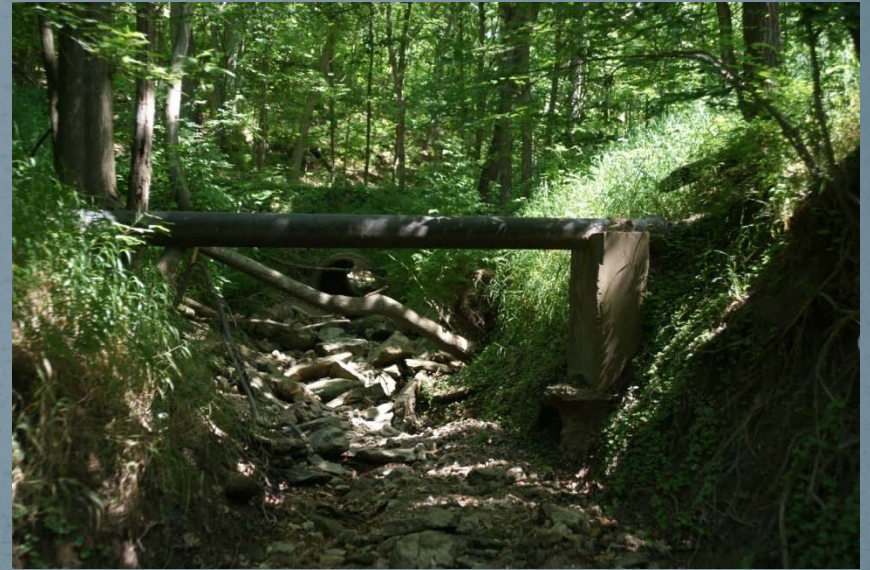
## Old pipe crossing

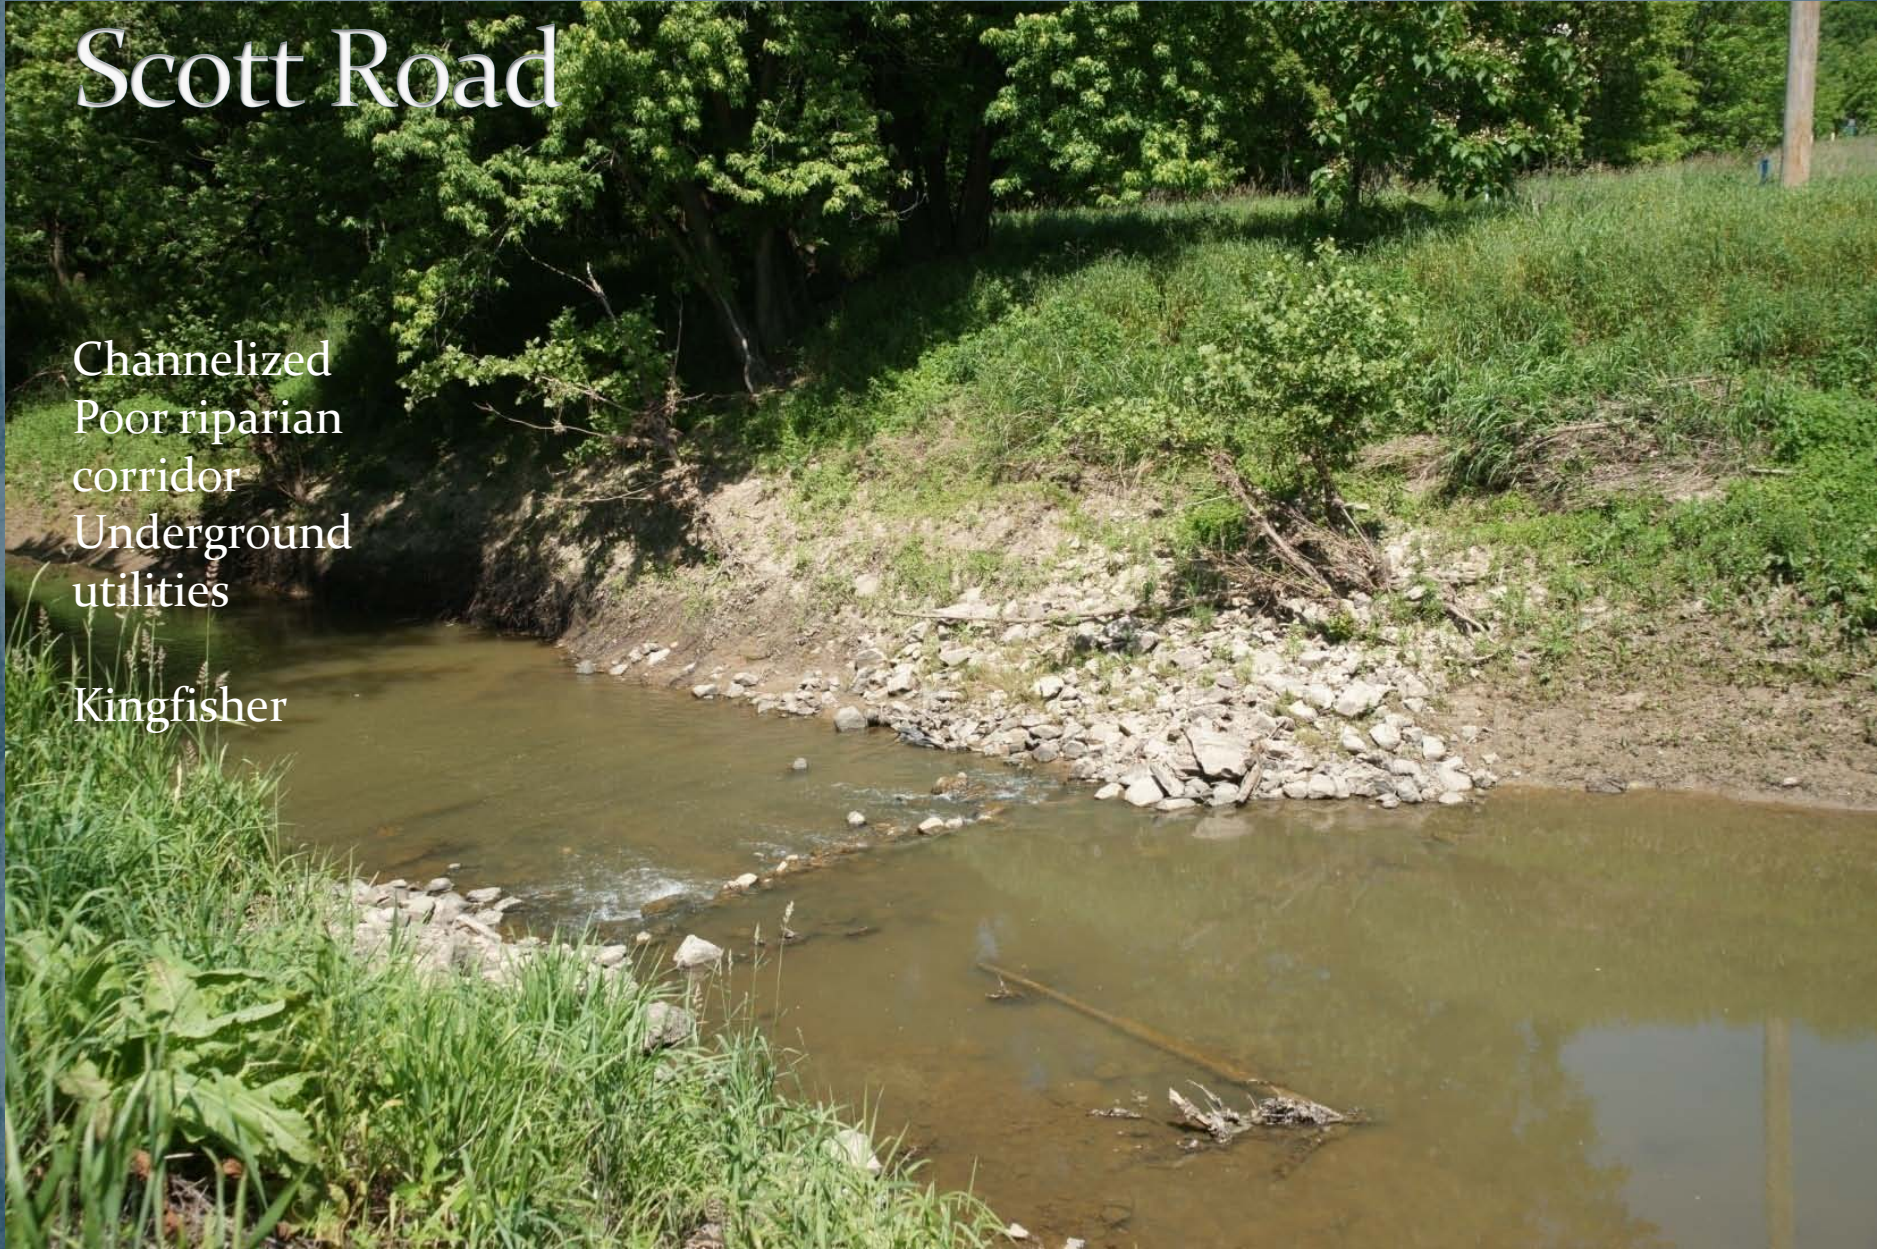
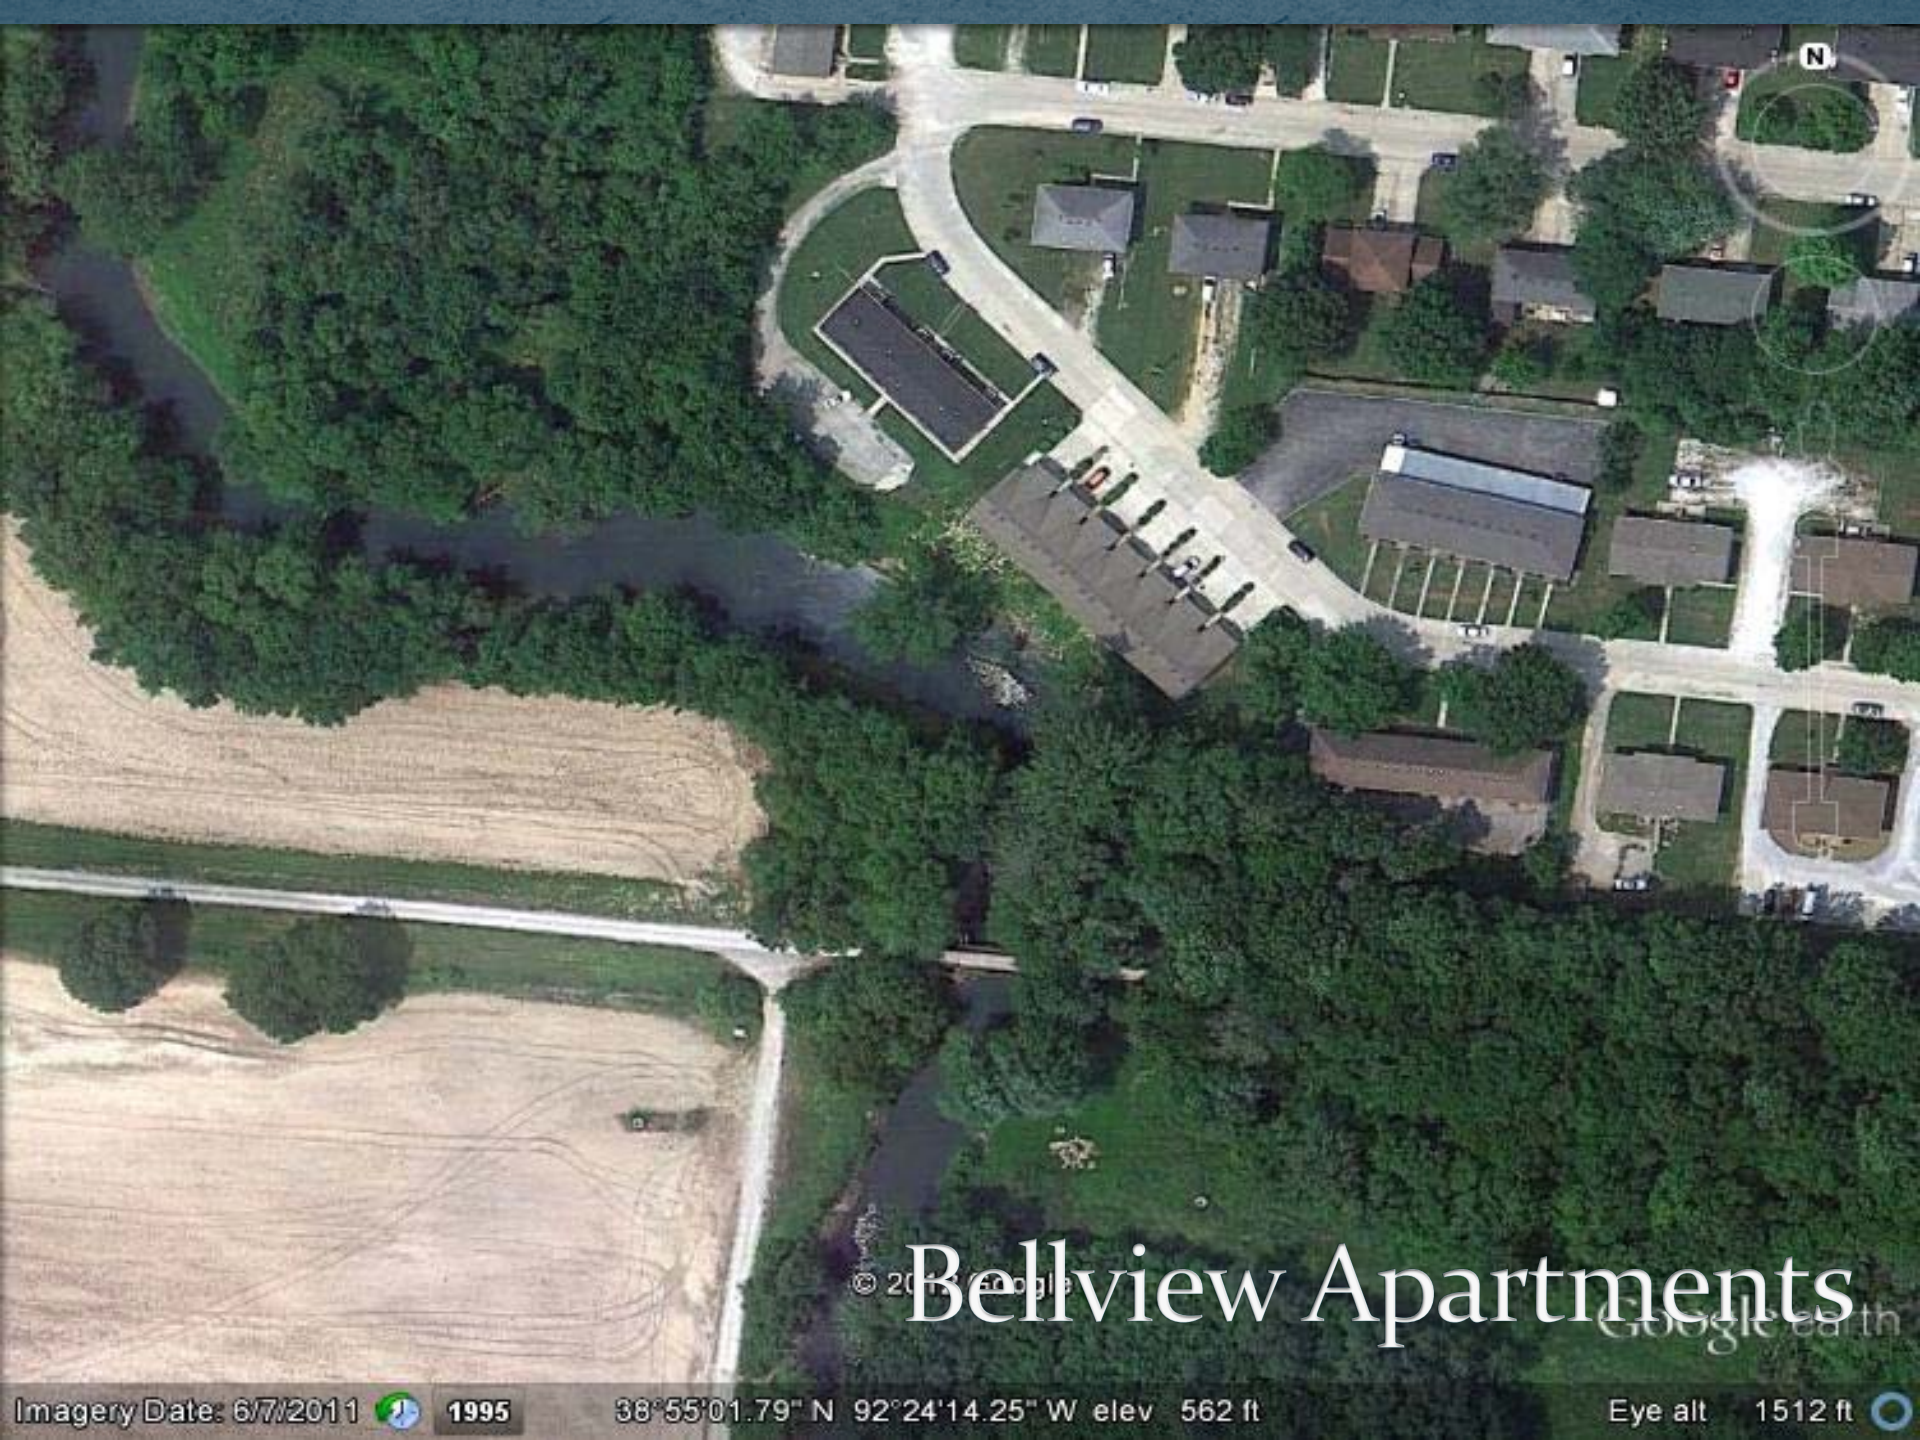
# Scott Road

Channelized  
Poor riparian  
corridor  
Underground  
utilities
