**Missouri  
Department of  
Natural Resources**

**Stream Survey Sampling Report**

**Hinkson Creek Stream Study  
Columbia, Missouri  
Boone County**

**November 22, 2004**

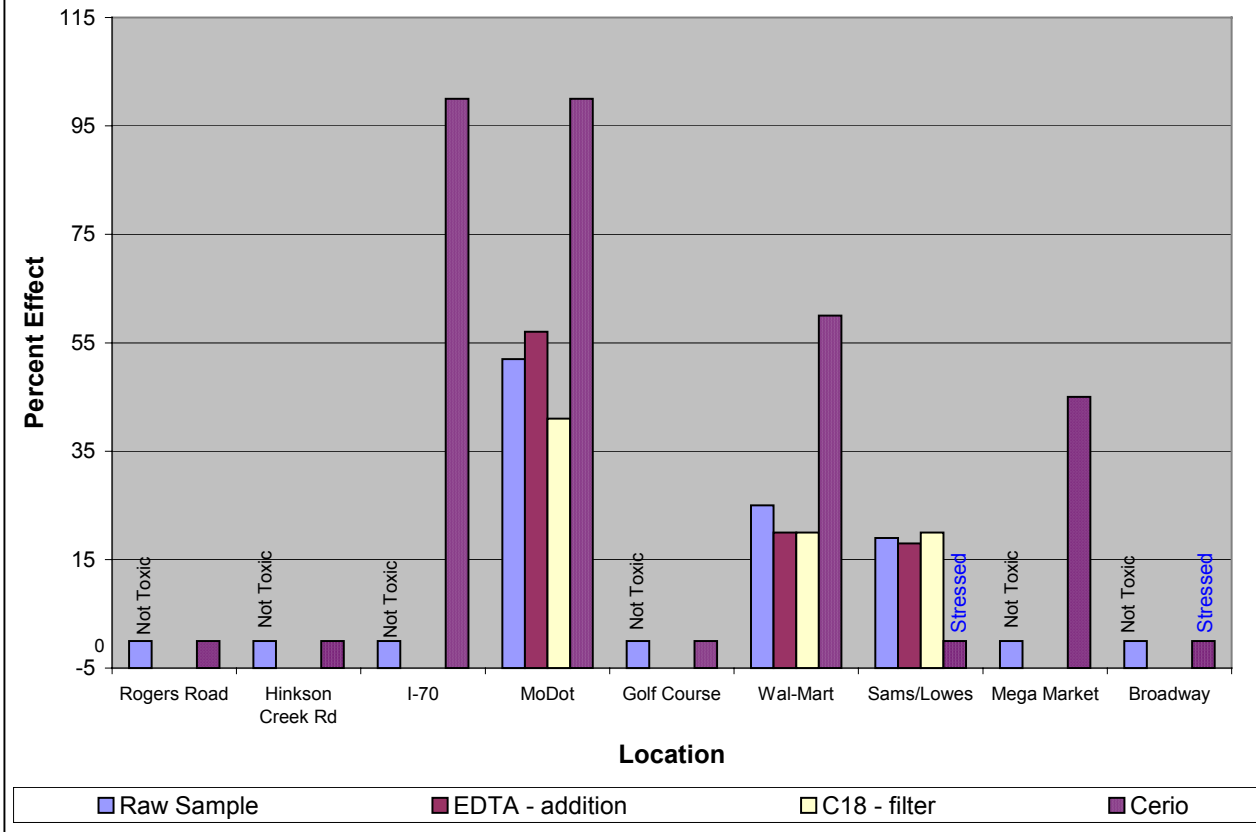
**Graph 1. Hinkson Creek Toxicity Identification - February 9, 2004**

Table 5 summarizes the snowmelt sampling event and results of toxicity testing. *C. dubia* were used in conjunction with Microtox during the February snowmelt sampling event. As shown in Graph 1, Microtox toxicity was observed at three monitoring sites (MoDOT, Wal-Mart, and Sam's/Lowe's). Of the nine samples tested for *C. dubia* toxicity, four showed acute toxicity (I-70 drainage, MoDOT, Wal-Mart, Mega Market) and two others (Sam's/Lowe's and instream at Broadway) exhibited sublethal toxicity. During this sampling event, *C. dubia* toxicity was found every time Microtox toxicity was observed and twice when Microtox toxicity was not observed. Although no Microtox toxicity was found instream at Broadway, sublethal toxicity to *C. dubia* was observed. This is significant because it documents that instream water conditions at this Hinkson Creek site were toxic to aquatic organisms.

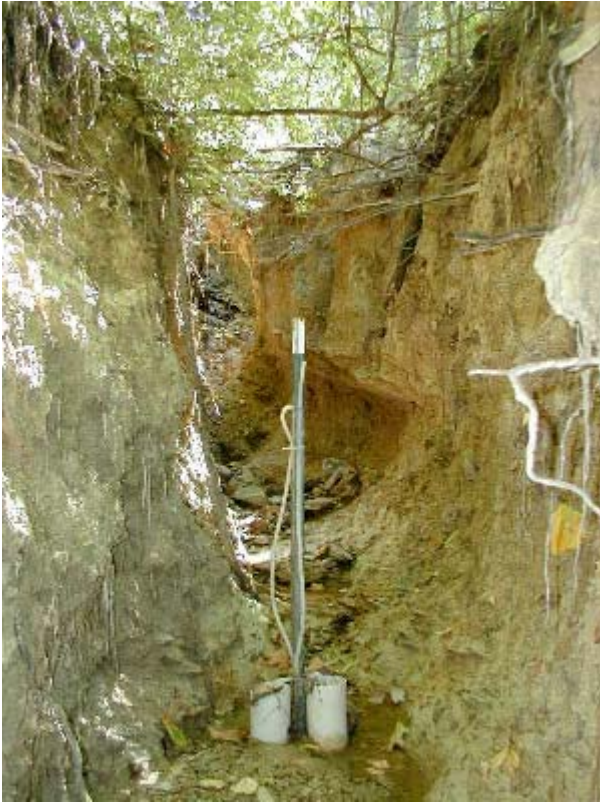
**Photo 1.** MoDOT Drainage

Throughout the study, severe soil erosion and gully erosion were observed occurring below many of the storm water discharge points. Gully erosion was estimated to be up to 8 feet in depth below the MoDOT maintenance facility and the Wal-Mart storm water discharges (Appendix B, photos 1 & 2). During the spring of 2004, a significant rainfall event in excess of three inches in approximately a 24-hour period occurred. The amount of runoff from the storm drainages was impressive (Appendix B, photo 3) and showed the potential for severe soil erosion and gully erosion. This may contribute to the observed sediment deposition and prolonged turbid conditions.

Approximate 8-foot gully erosion

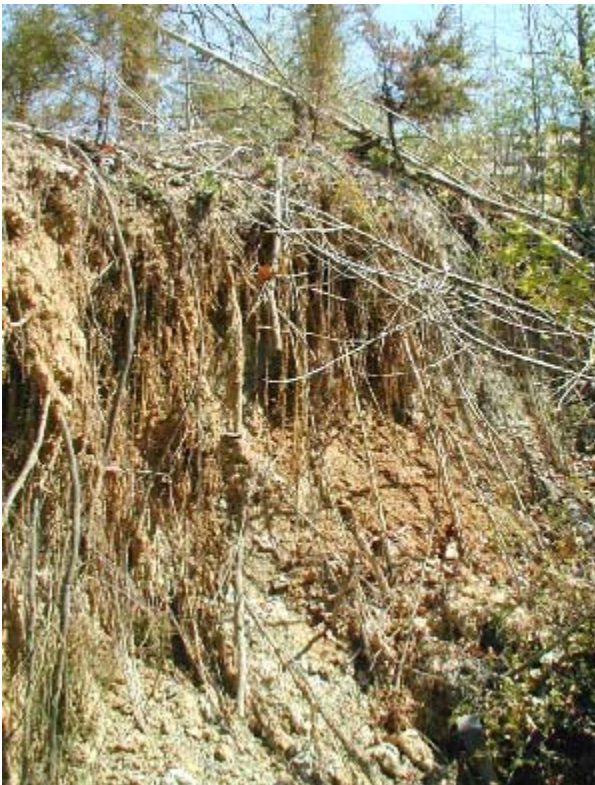
**Photo 2.** Wal-Mart Drainage

Approximate 8-foot gully erosion

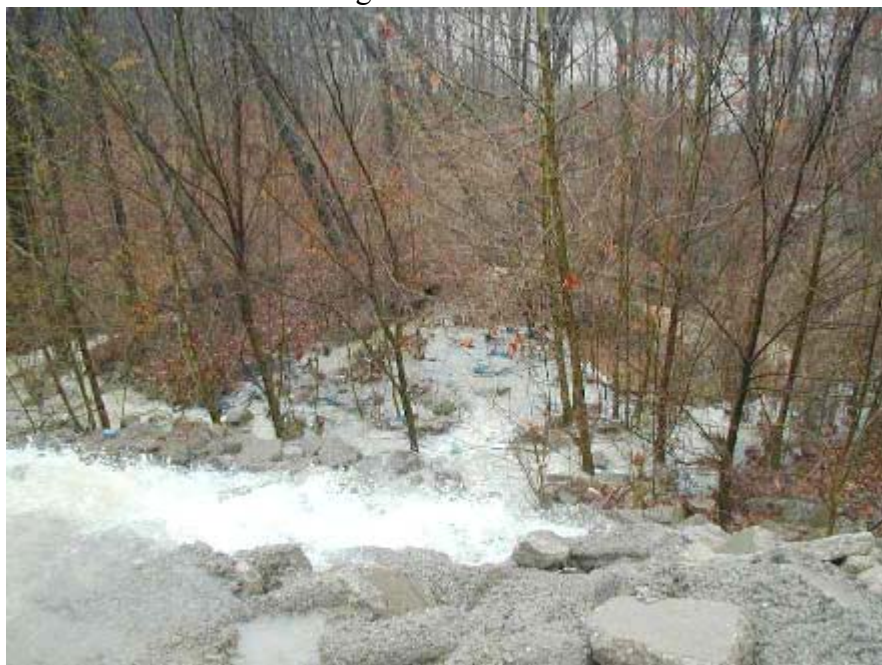
**Photo 3.** Wal-Mart Drainage

During significant storm water runoff event

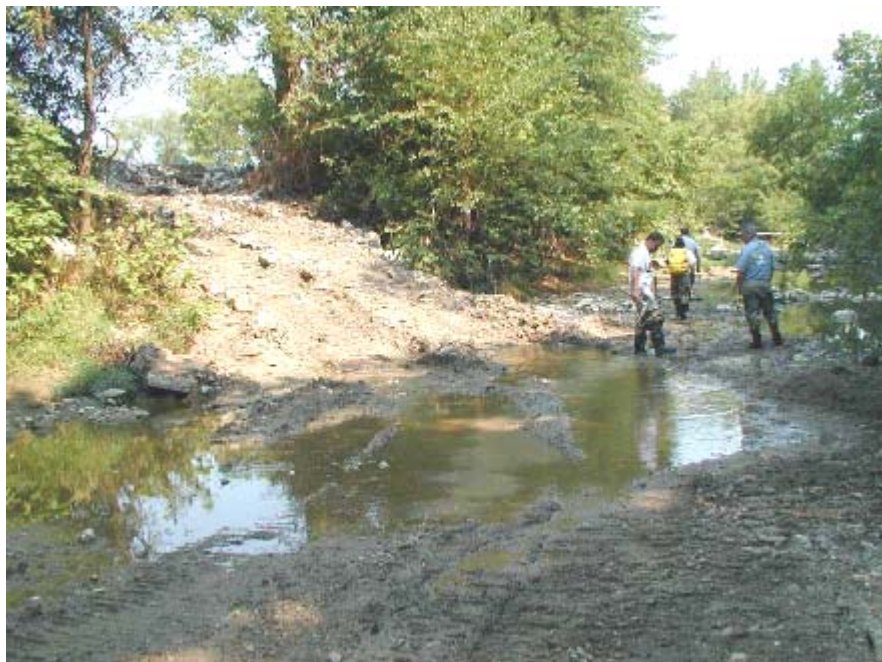
**Photo 4.** City of Columbia sewer line upgrade

Walnut bridge. In addition, the City of Columbia bored under Hinkson Creek upstream of the East Walnut bridge. At these locations, excess sediment was noted. During a summer of 2003 site visit, Department of Natural Resources ESP staff noted that best management practices (e.g. erosion controls, silt fences, etc.) were not in place. Contact was made with the Northeast Regional Office where a Department of Natural Resources inspector worked closely with the City of Columbia and contractors to install and utilize best management practices.

Equipment crossing located upstream of the East Walnut bridge crossing.

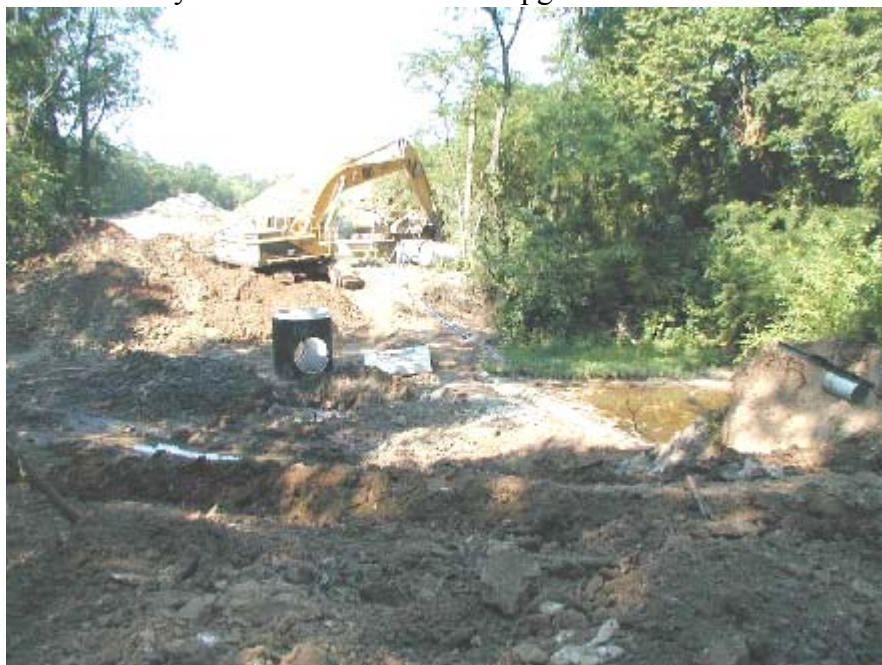
**Photo 5.** City of Columbia sewer line upgrade

Construction and equipment crossing located downstream of the East Walnut bridge crossing.

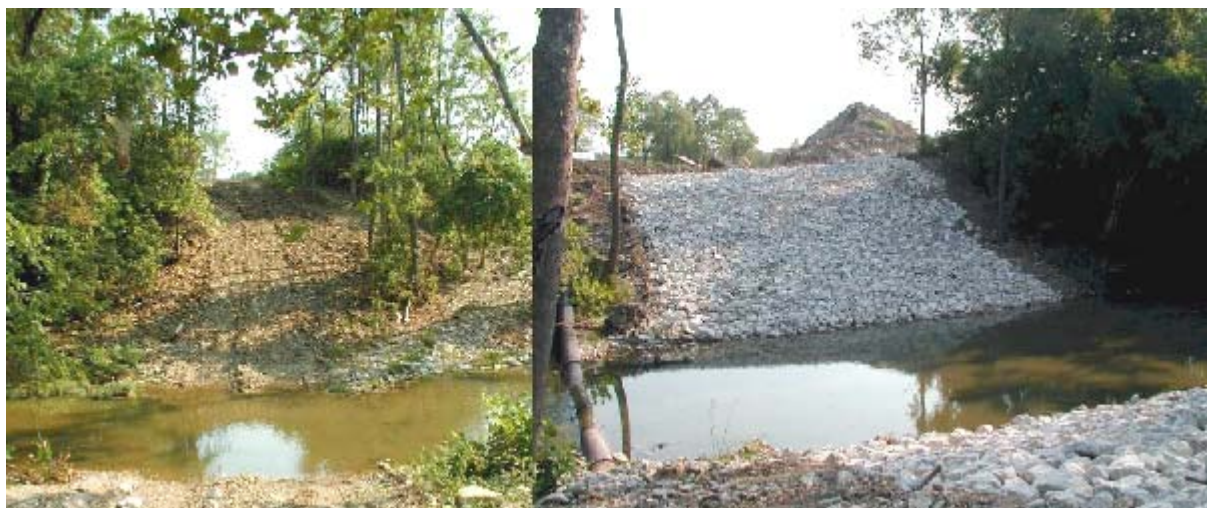
**Photo 6.** City of Columbia sewer line upgrade

Construction and equipment crossing located upstream of the Broadway bridge crossing.
