Missouri
Department of
Natural Resources

Stream Survey Sampling Report

Phase II Hinkson Creek Stream Study Columbia, Missouri Boone County

July 2004-June 2005

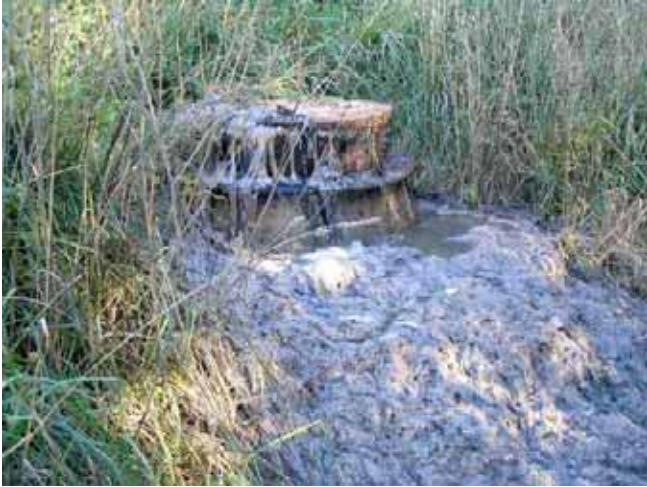
Photo 1.

Raw wastewater discharging from manhole located behind Wal-Mart in the Broadway Market Place Shopping Complex.

Sewer line had become clogged by tree roots and grease causing wastewater to back up into the manhole.

- Periodic sewer line breaks and/or bypasses can contribute to elevated in-stream *E. coli* readings. The following are examples of some occurrences.
 - On at least one occasion a sewer line bypass occurred during the study. The bypass occurred at a manhole located behind the Wal-Mart store located in the Broadway Market Place shopping complex on August 10, 2004. The sewer lines had become plugged with tree roots and grease, which caused raw wastewater to overflow from the manhole and enter Hinkson Creek (refer to Appendix B, Photos 1-3).

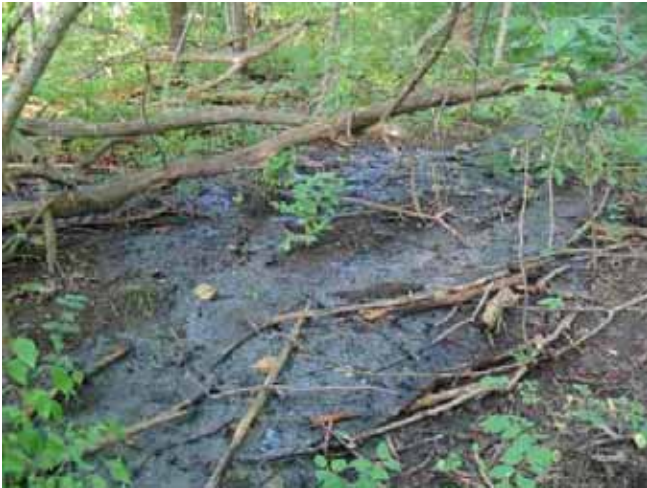
Photo 2.

Raw wastewater overflowed from the manhole and downhill through a wooded area before collecting in a backwater area of Hinkson Creek.

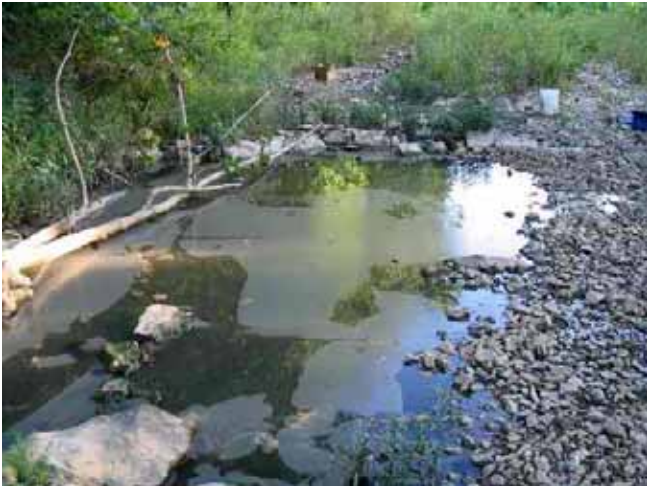
Photo 3.

The raw wastewater that pooled in the backwater area of Hinkson Creek then seeped through the gravel bar and entered main-stem Hinkson Creek.
