# Hinkson Creek

Virtual Tour

# Hinkson Creek Facts

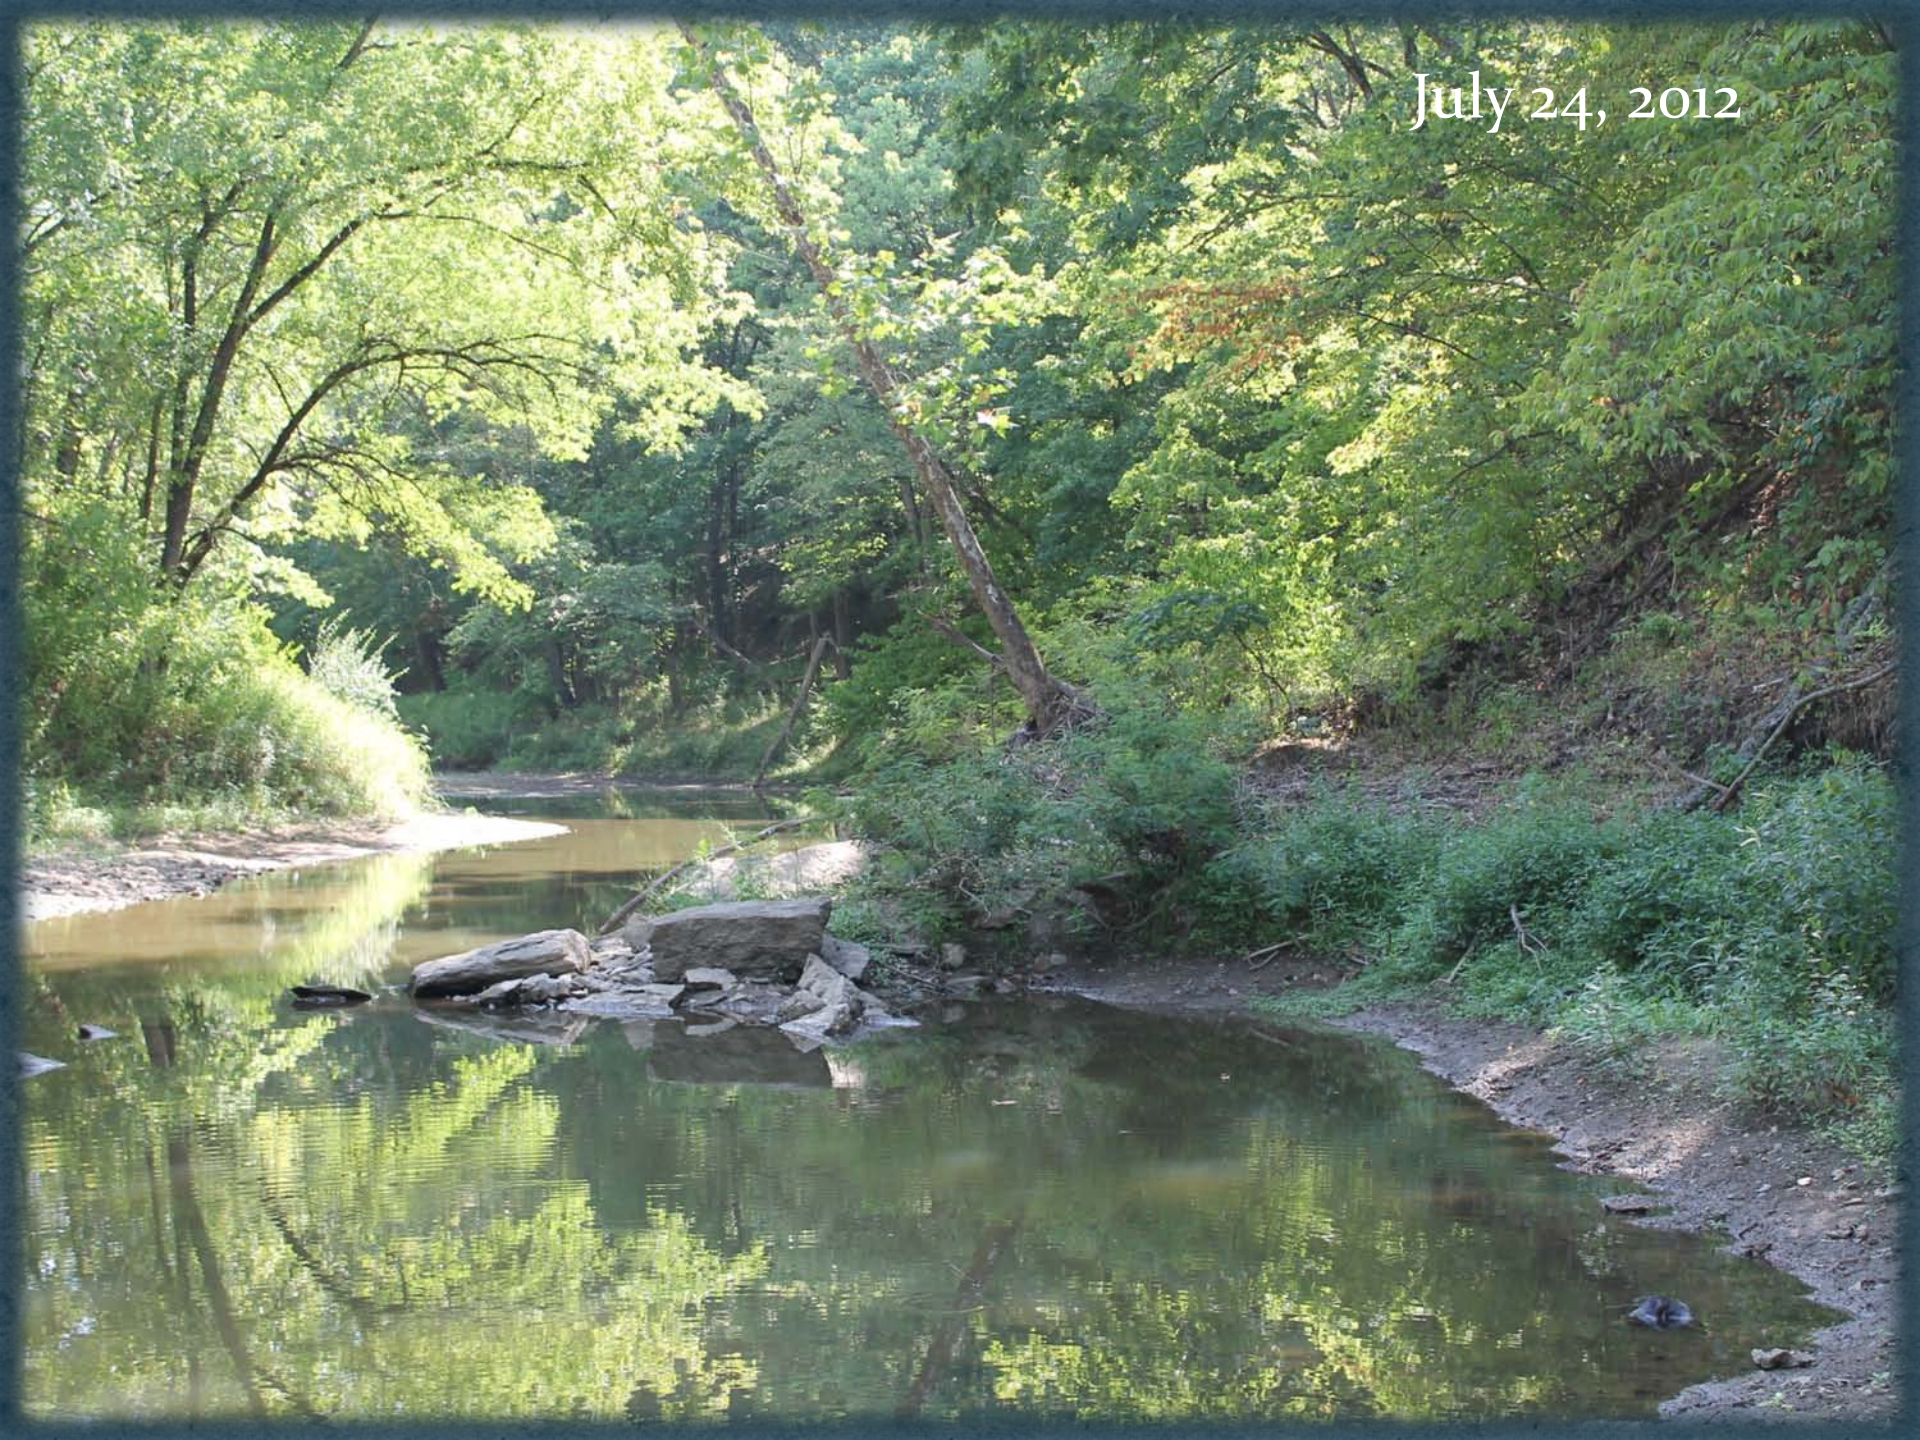
# Highway 63 Connector

- Higher nutrients
- Algae
- Wide channel

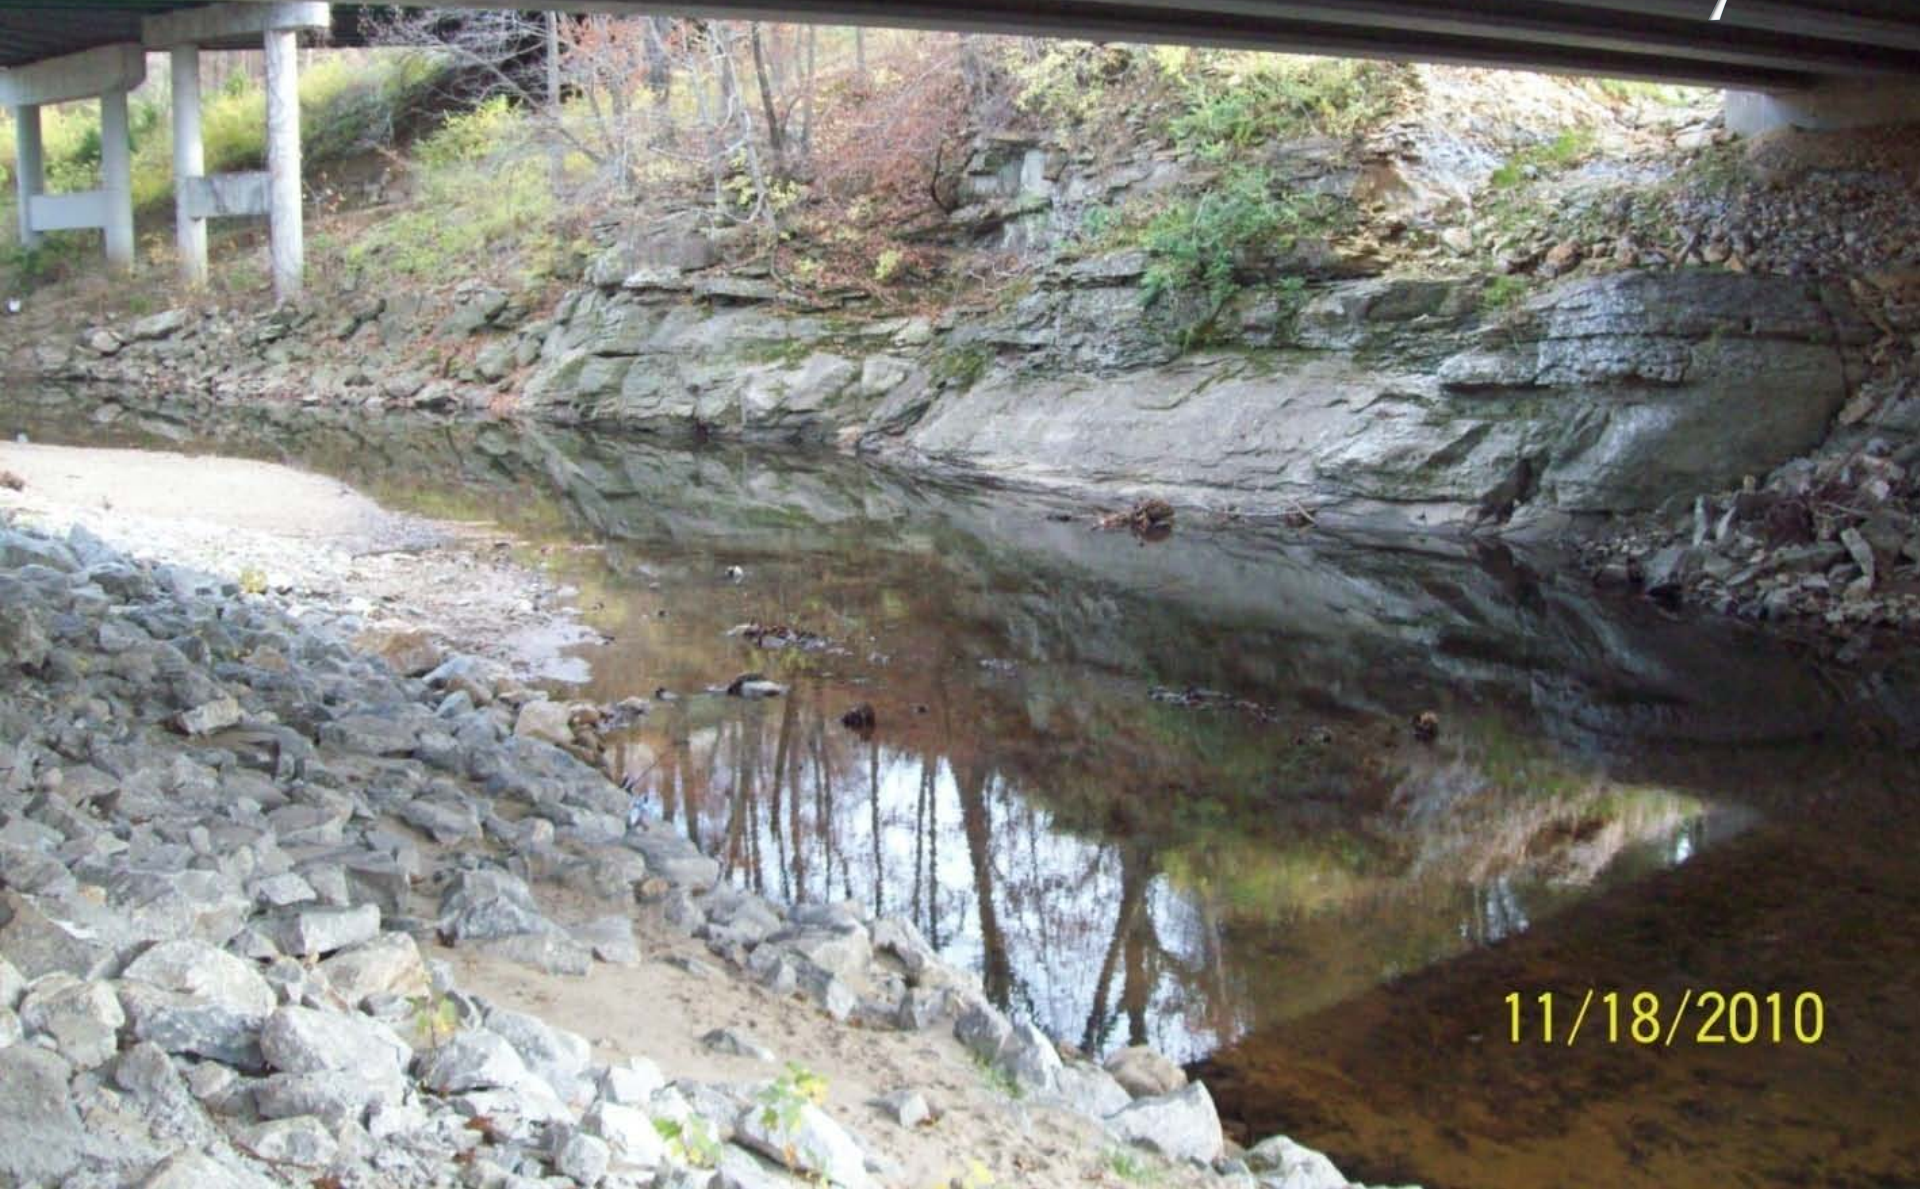
Under I-70

- Streams are dynamic systems reacting to:
  - stream flow,
  - slope or
  - velocity changes
- The new channel
  - Cut off from previous flood plain

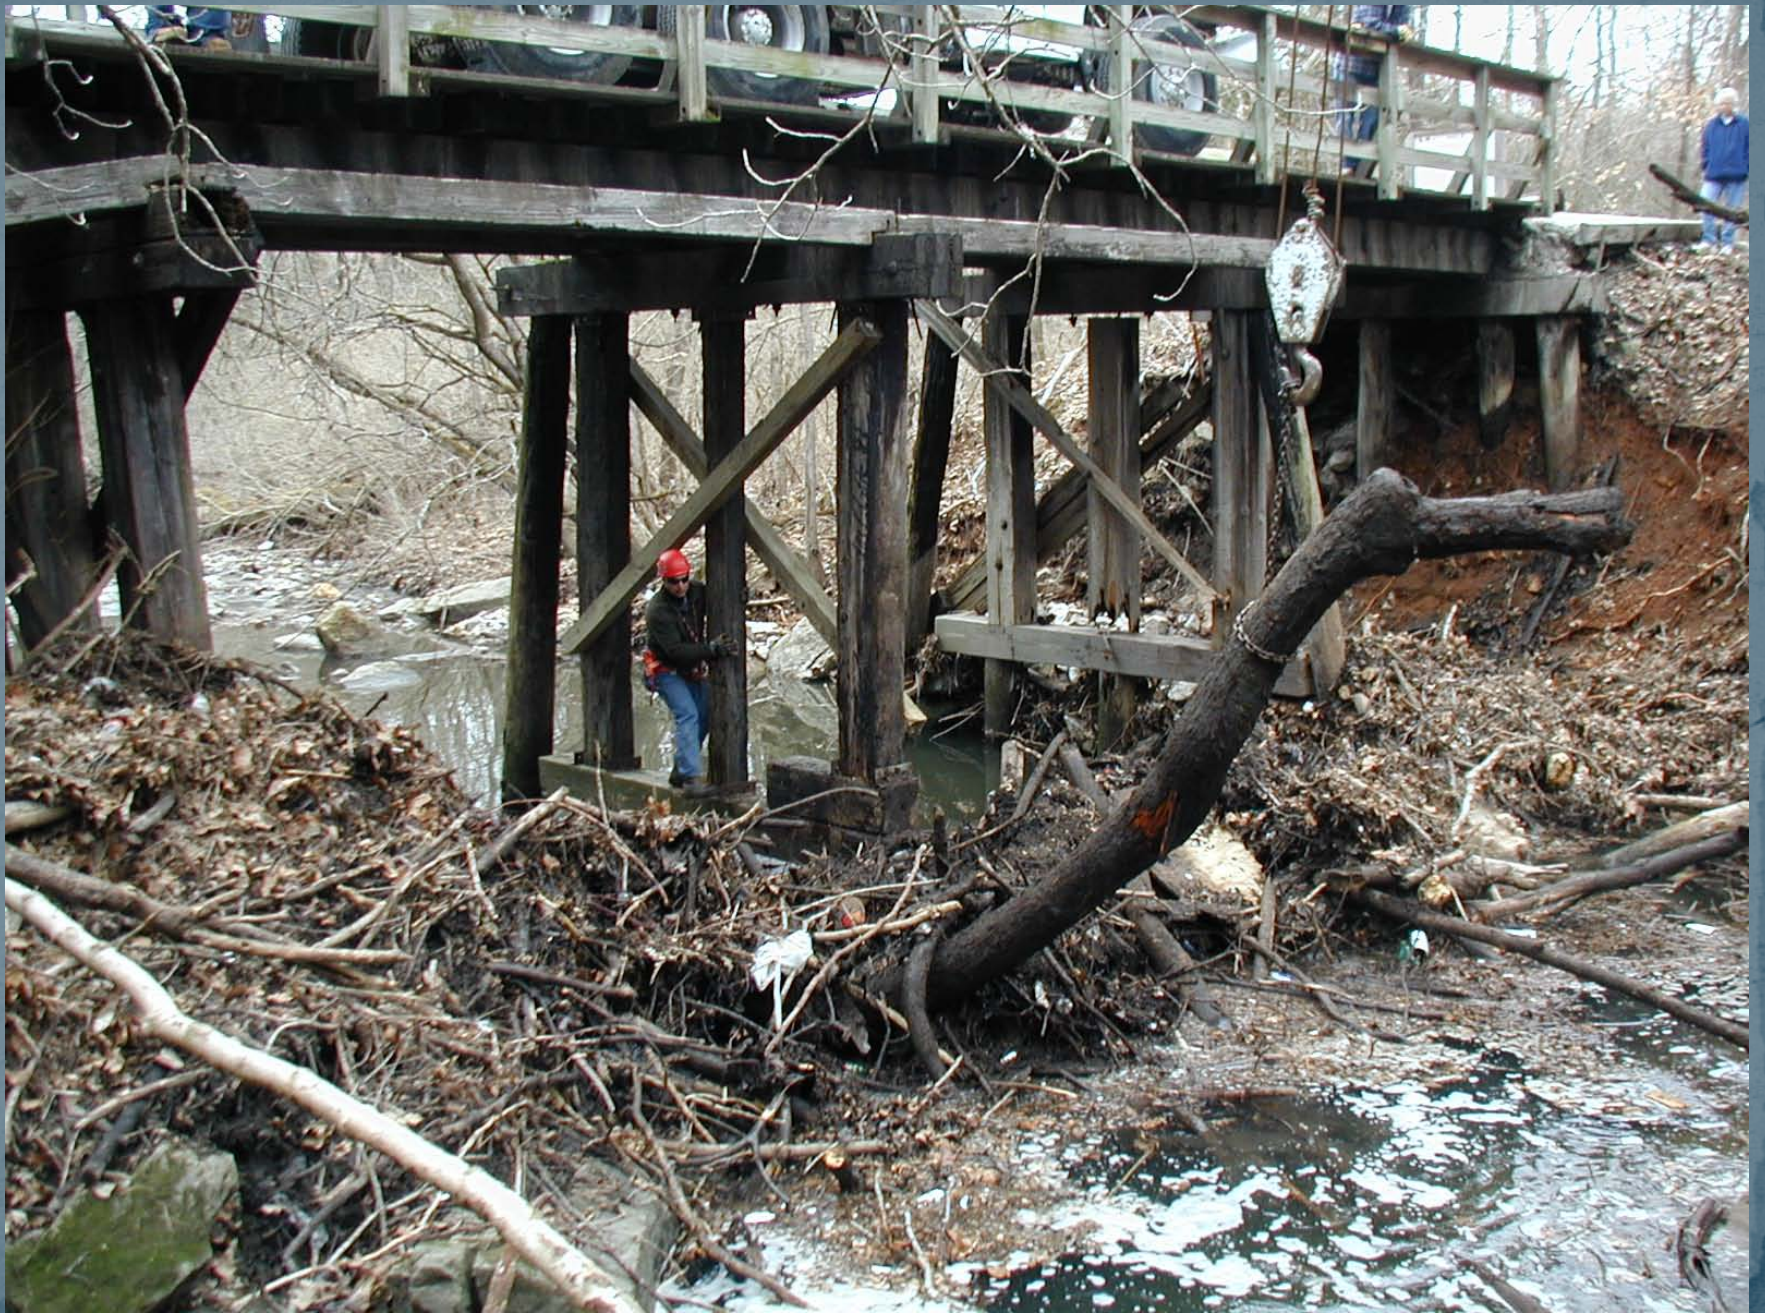
- Typically occurs October through April
- Stalled weather system that dumps several inches over a period of 1-2 weeks
- Saturated soils
- Winter/Spring events prior to leaf out
  - Little canopy to capture rainfall
  - low transpiration to remove water from soils
- Rain on Snow events
  - December 2010, February 2011
